# Manhole Inspection Summary

Manhole # S37A\_\_008MH

**Inspection** ☐ Is Incomplete Rating: **3) Fair**

Insp Date: **8/25/08 11:11 AM**

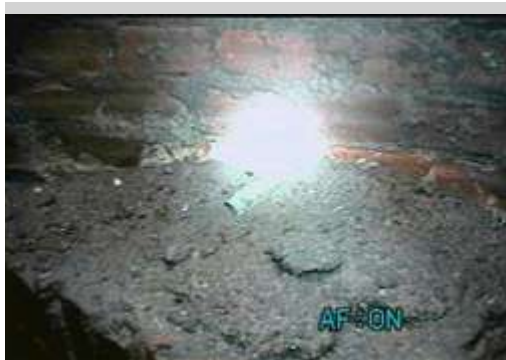
Defect 3

Condition: ☐ Sound ☐ Cracked ☐ Root Intrusion ☐ Deteriorated ☐ Leaks ☒ **Debris**

bench debris

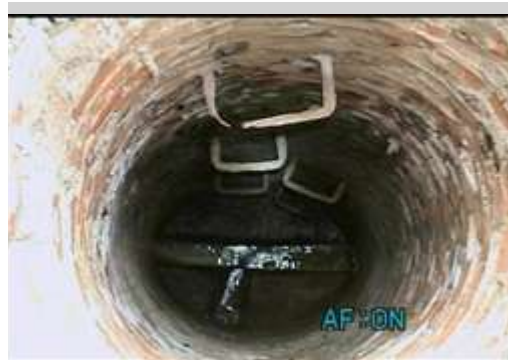
Defect 2

**Steps** Count: **6** Missing: **2** ☒ **Corroded**

steps

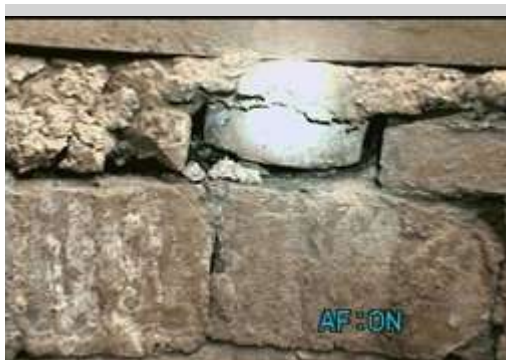
Defect 1

Condition: ☐ Sound ☒ **Cracked** ☐ Root Intrusion ☐ Loose Brick ☒ **Deteriorated**

cracked, deteriorated, frame adj
